Limited Visual Dam Safety Inspection Summary Report

MA-128

Napili 2-3 Desilting Basin

May 2006

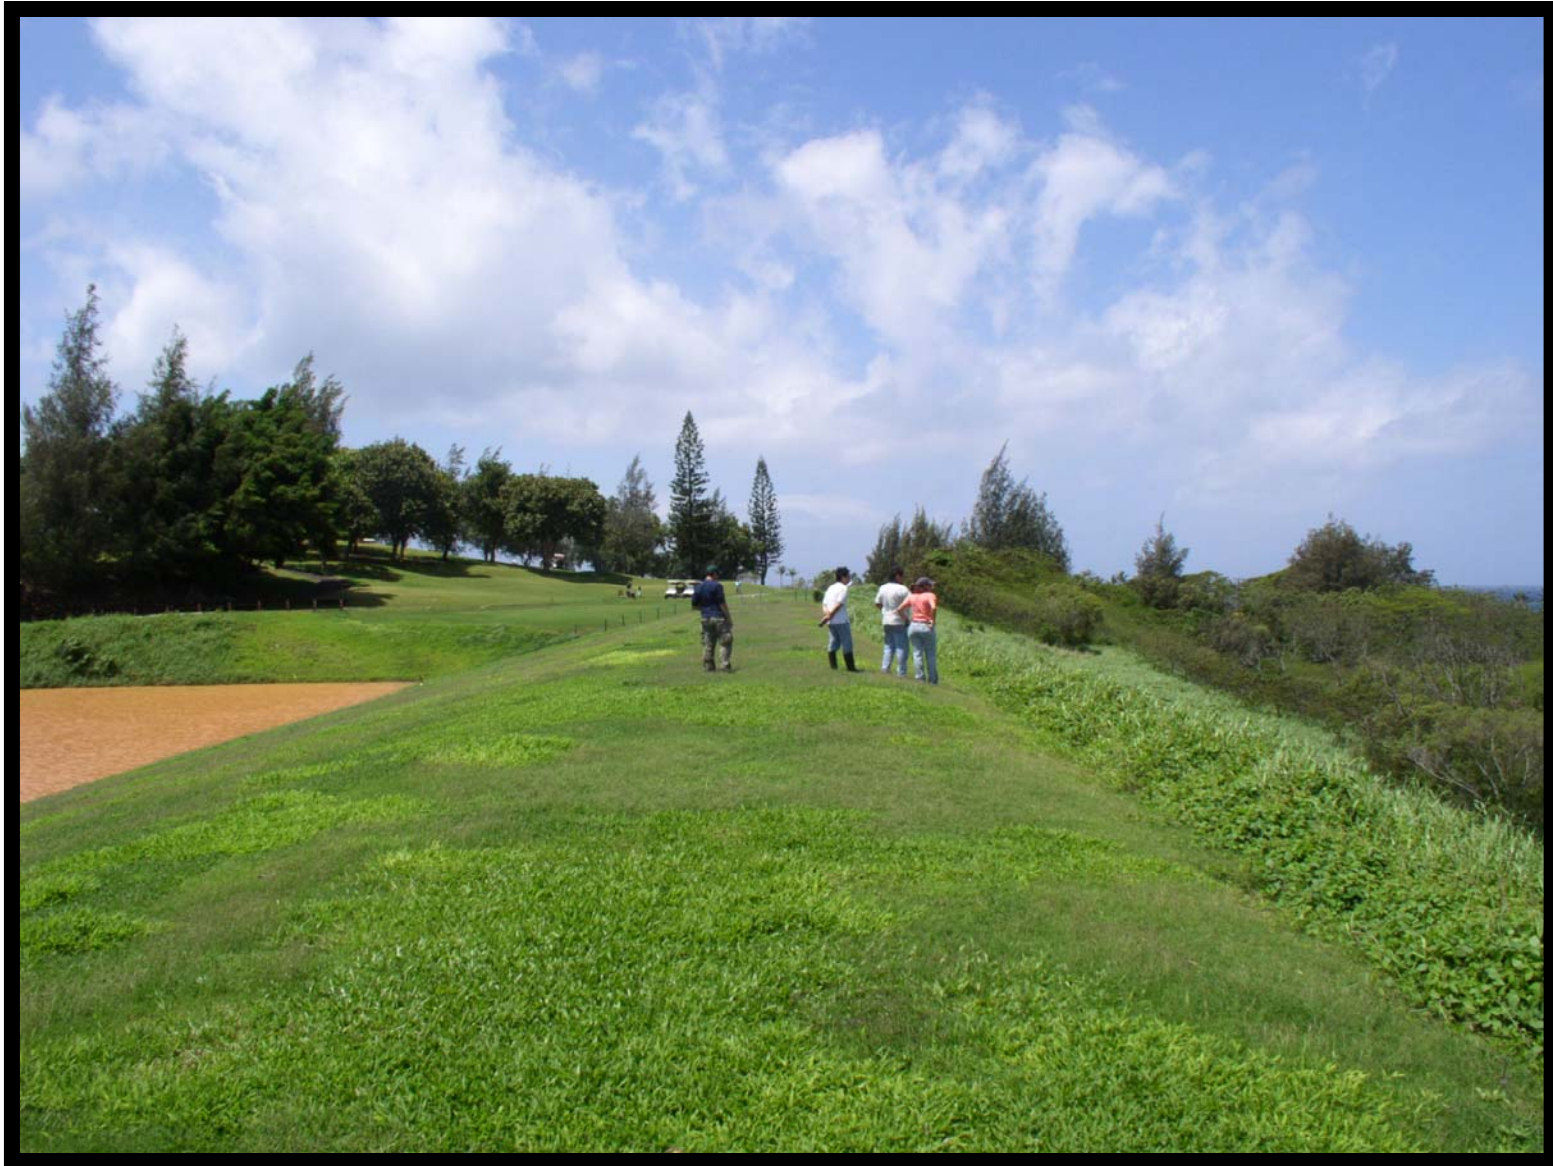
- a. The dam crest appeared to be in satisfactory condition. No corrective actions are required at this time.
- b. Access along the crest was satisfactory.

128 Crest

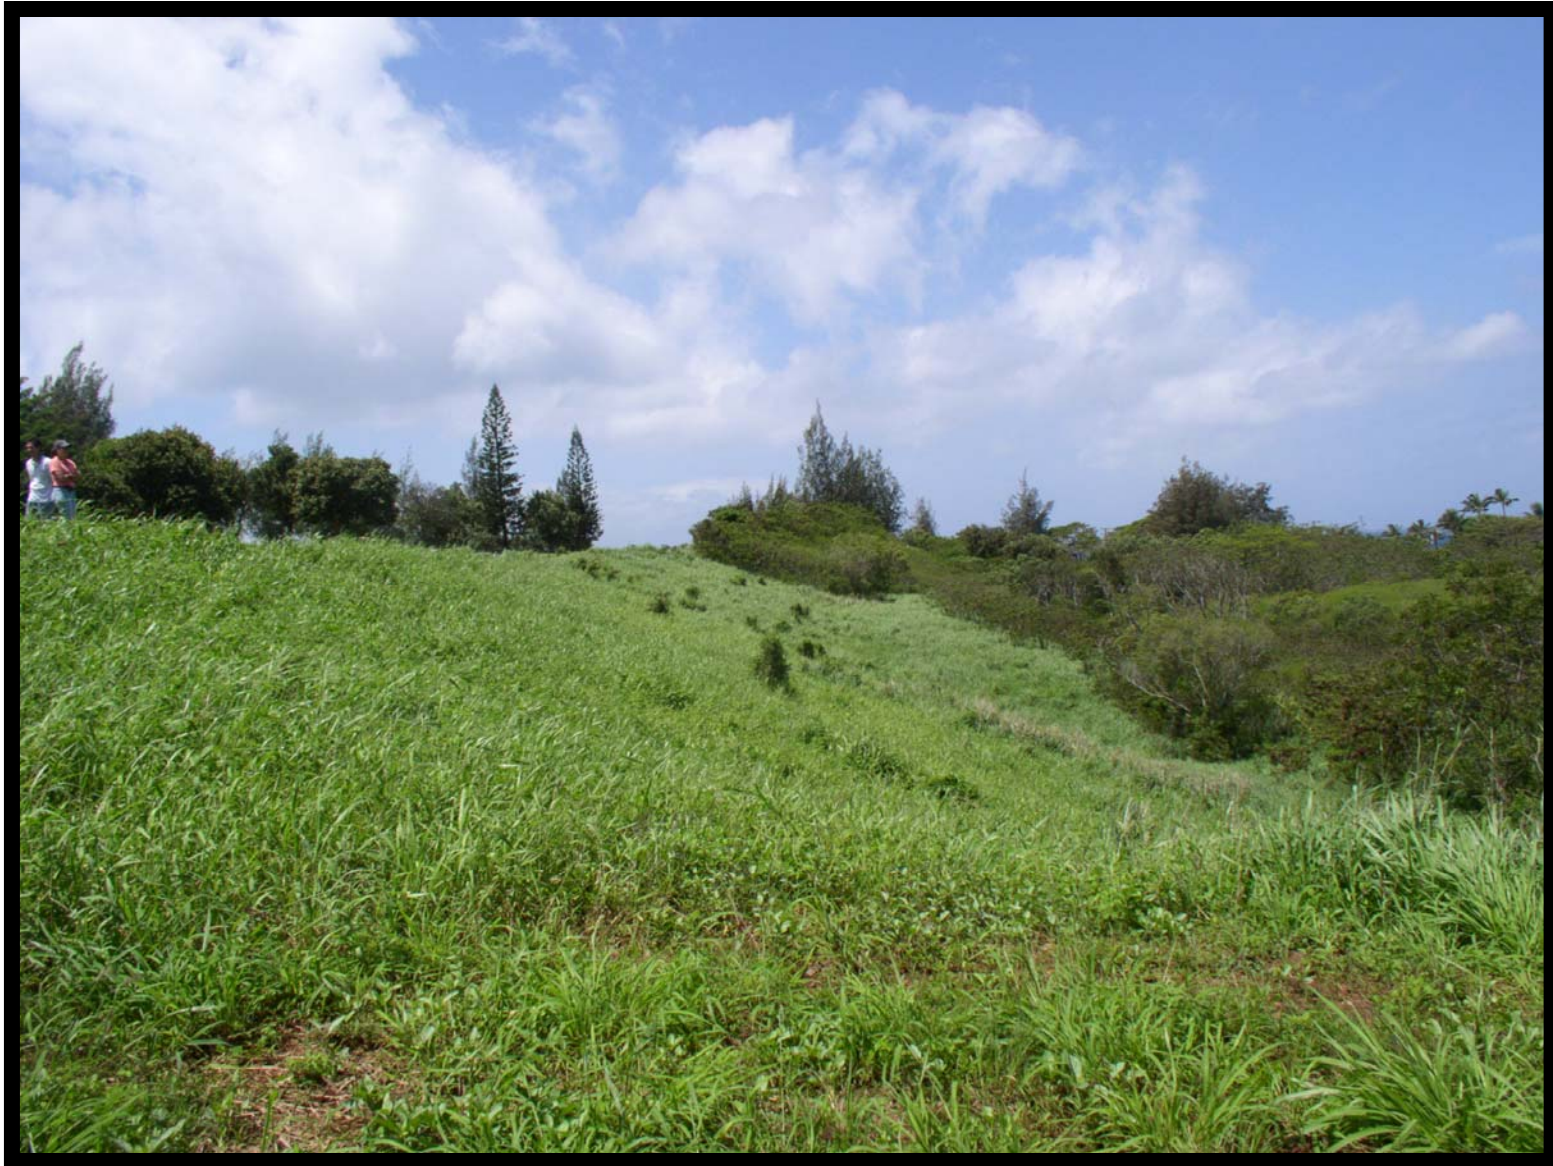
- a. The downstream slope appeared to be in satisfactory condition. No corrective actions are required at this time.

128 Downslope

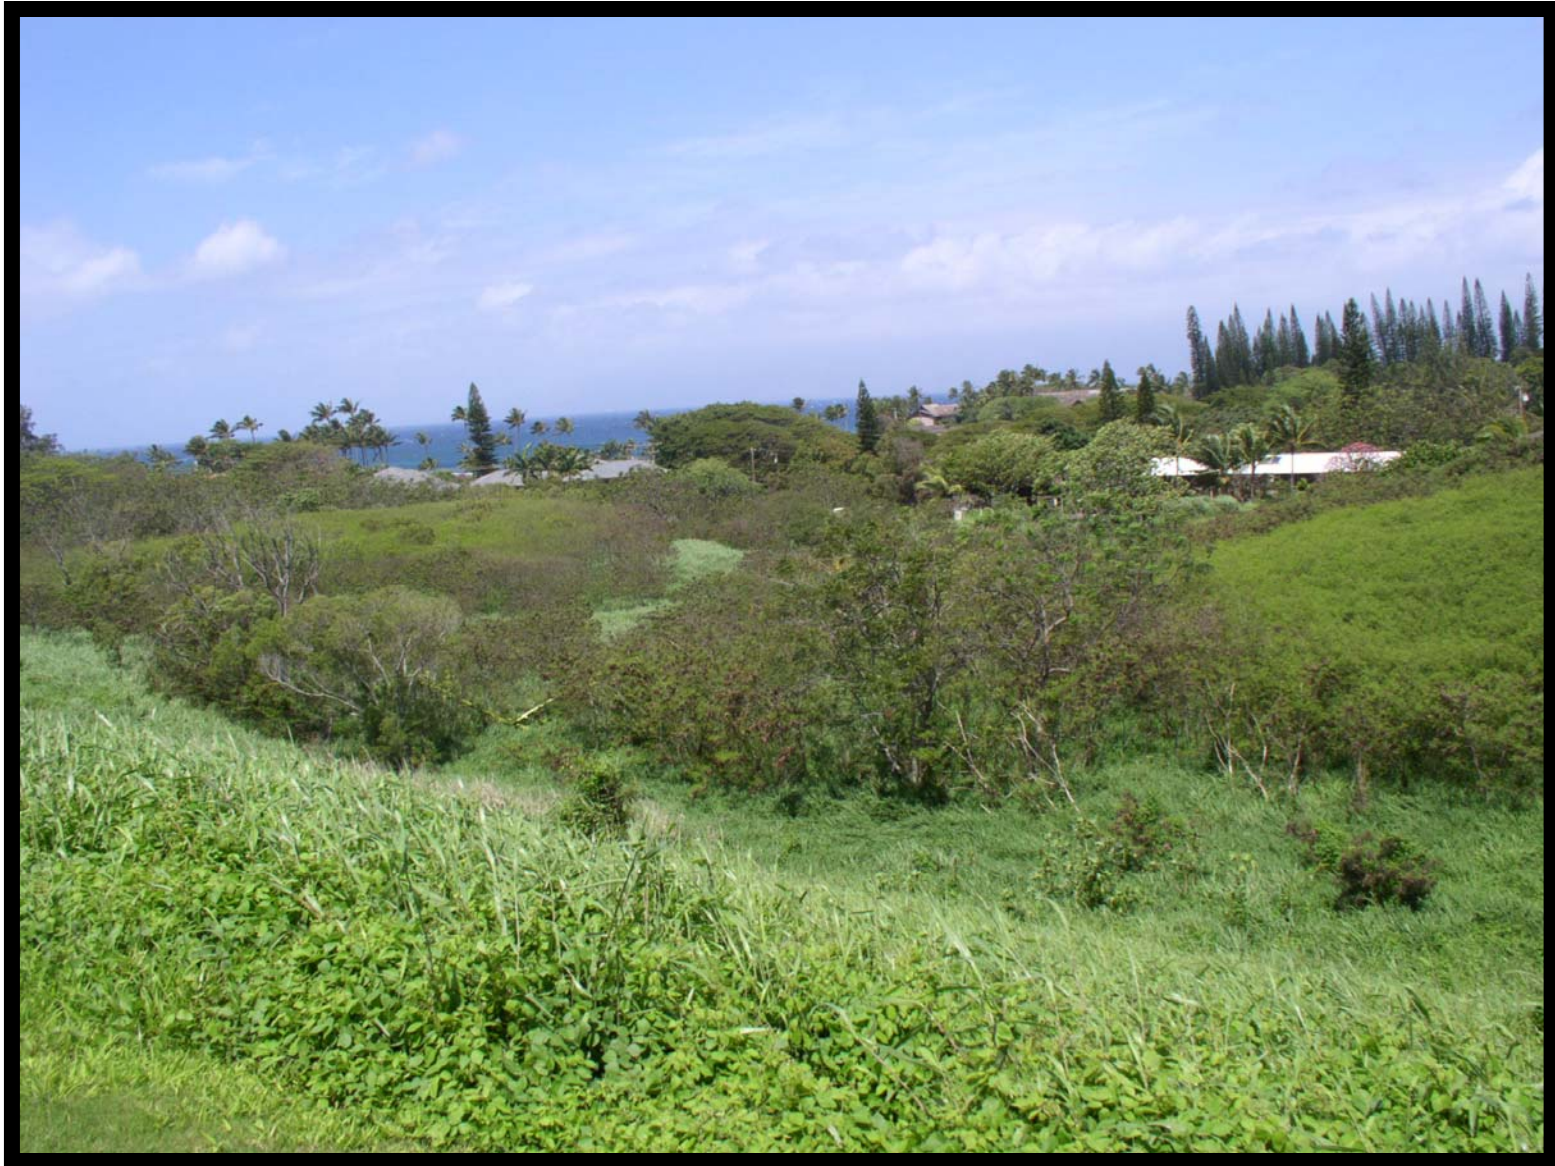
128 Downstream – view from the crest looking downstream

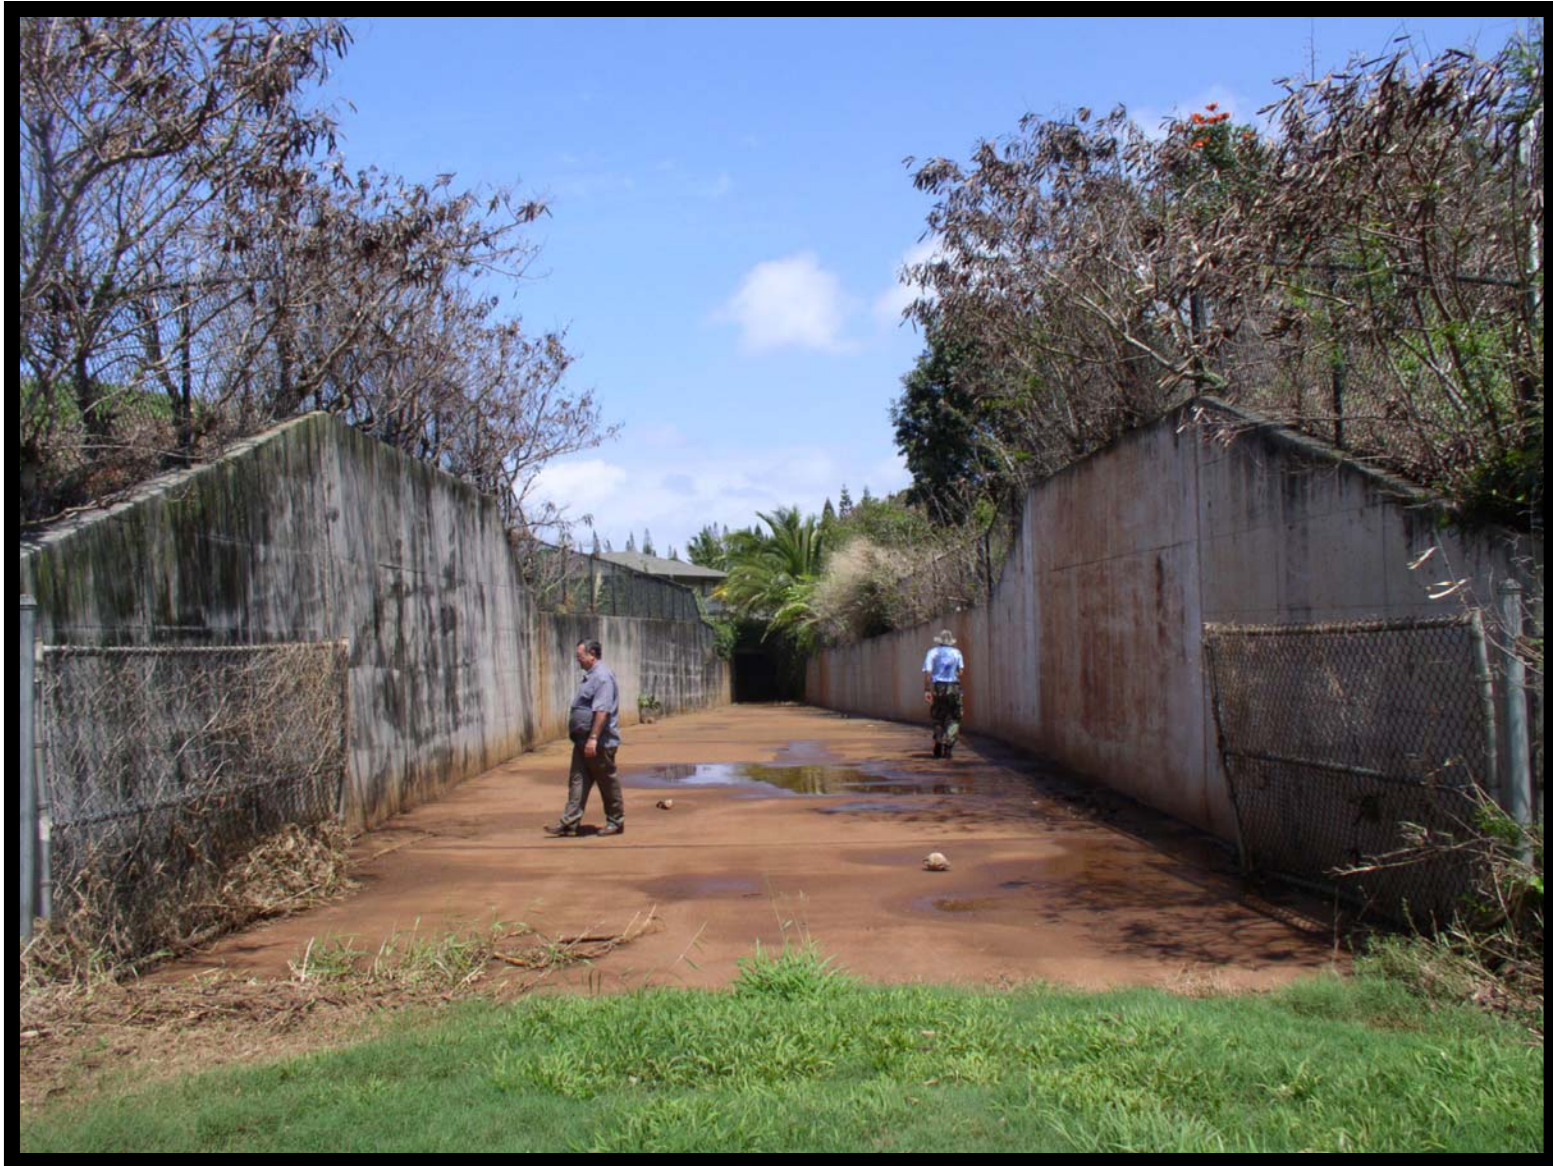
The outlet works were not tested. The outlet works consist of a DIP, which was not inspected and has not been opened ever because it could flood downstream homes, per the owner. Flow is managed through the spillway.

- a. The outlet works were not inspected.
- b. The outlet works were not tested.
- c. The outlet works appear to be in unsatisfactory condition and are not expected to fulfill its intended function.
- d. Outlet works valve is broken per owner.

128 Outlet – view of dam outlet channel

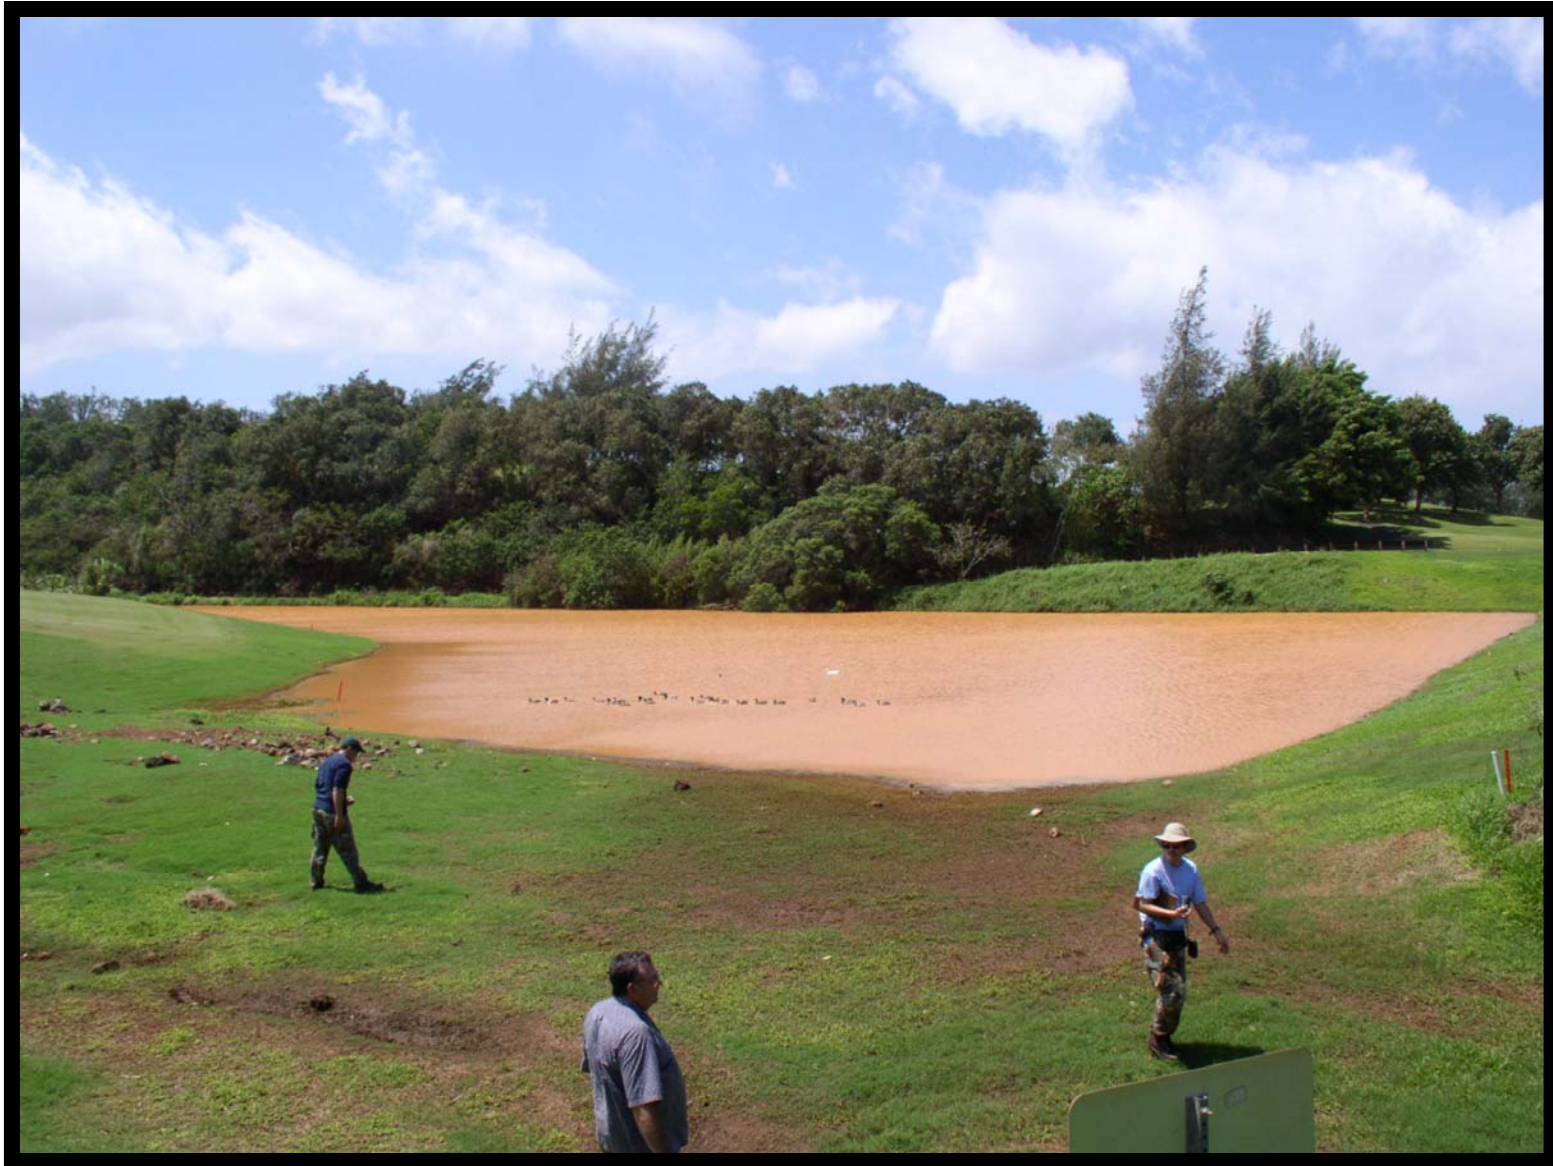
The reservoir was estimated to be approximately 6 feet deep at the time of inspection. The normal operating level is estimated to be 6 to 7 feet. No staff gage was observed.

- a. The reservoir appeared to be in fair to poor condition and requires corrective action.
- b. A staff gage was not observed at this reservoir. Provide some method of quantifying the water level within the reservoir.

128 Reservoir - This is also a water hazard for the Maui Golf Course

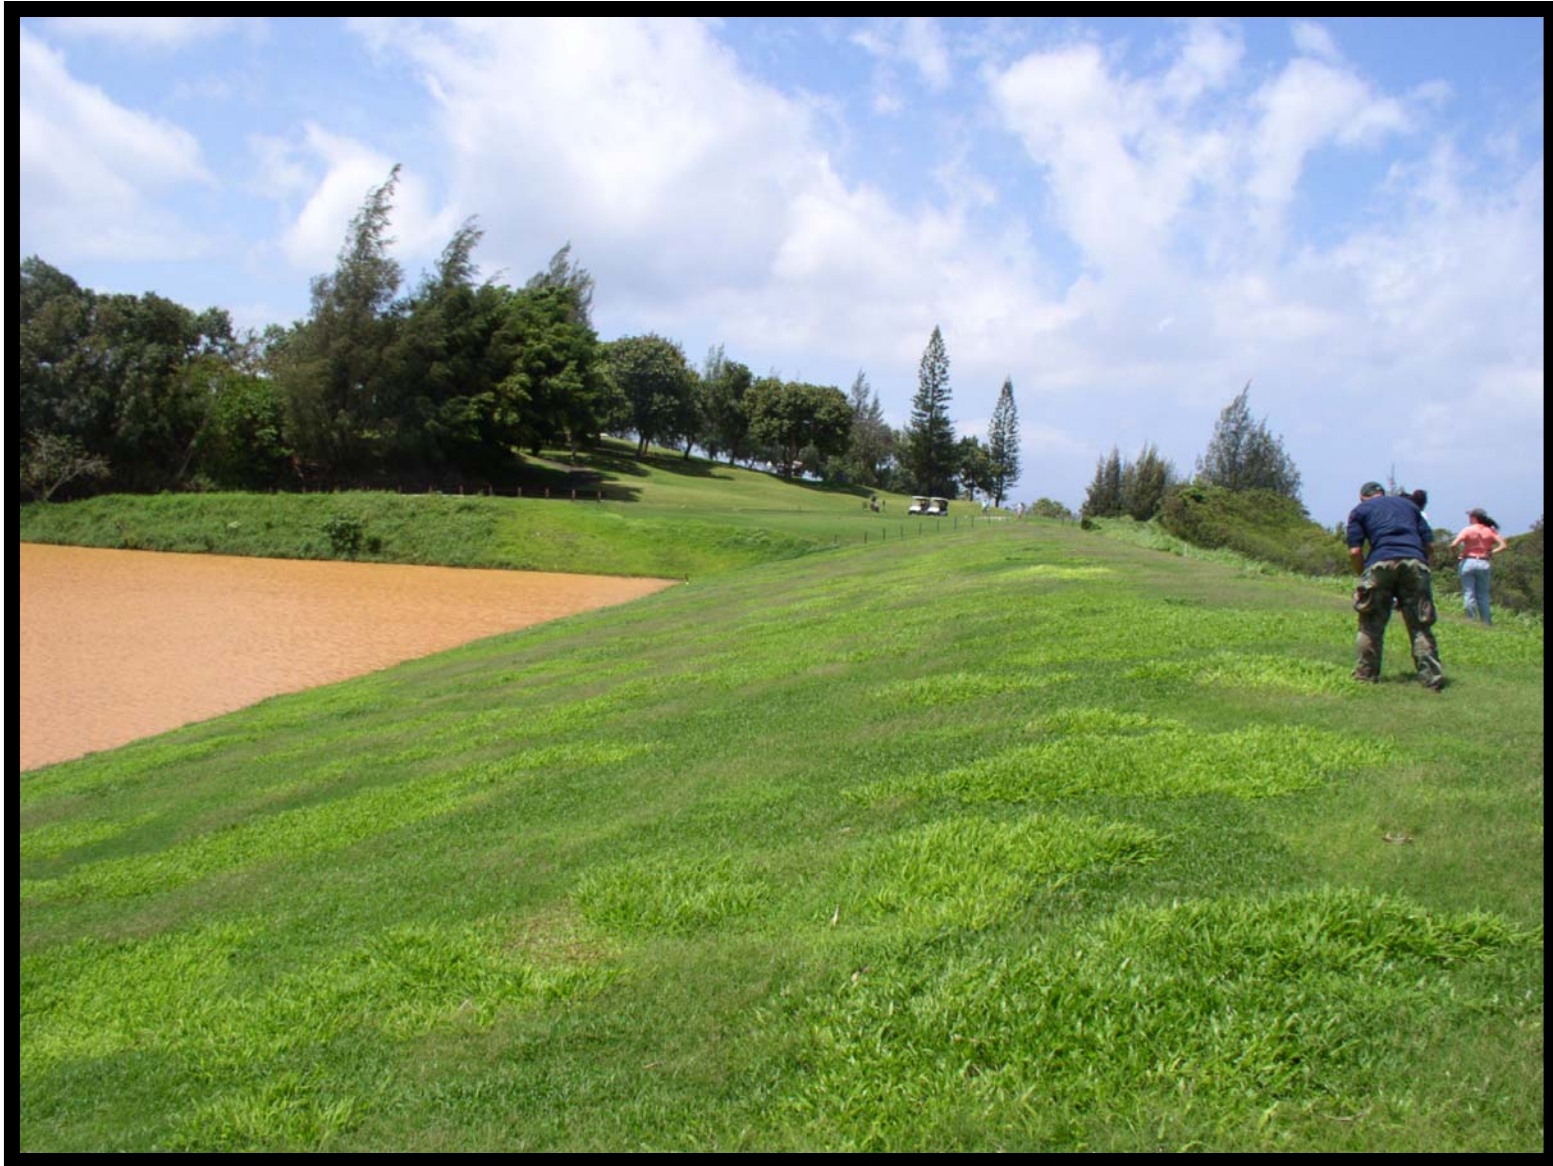
- a. The upstream slope appeared to be in satisfactory condition. No corrective actions are required at this time.

128 Upslope
